Ridgewood Pool EXECUTIVE SUMMARY

PROVIDED BY FINDORFF

5109 Barton Rd • Madison, WI 10.07.2022

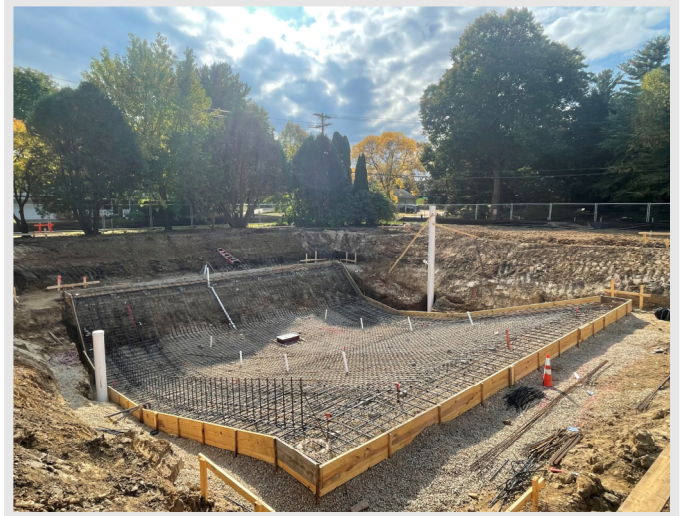
Above: Reinforcing at the slab of the new dive well is nearly complete and the concrete slab pour will soon follow.

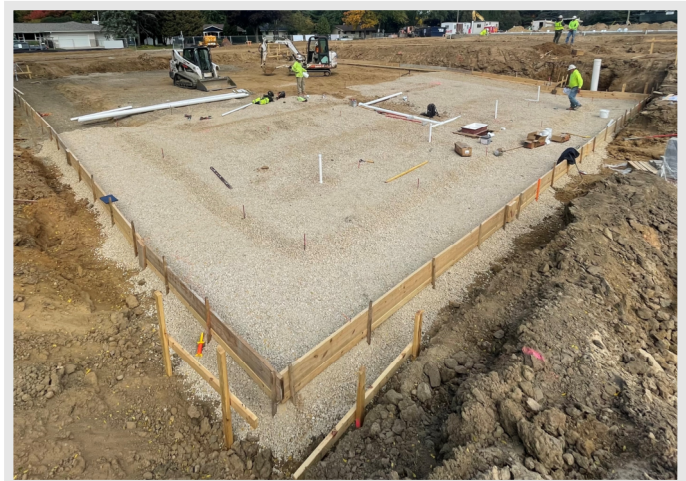
Below: Stone subbase and under pool piping is well underway at the new lap pool and reinforcing will be starting next week.

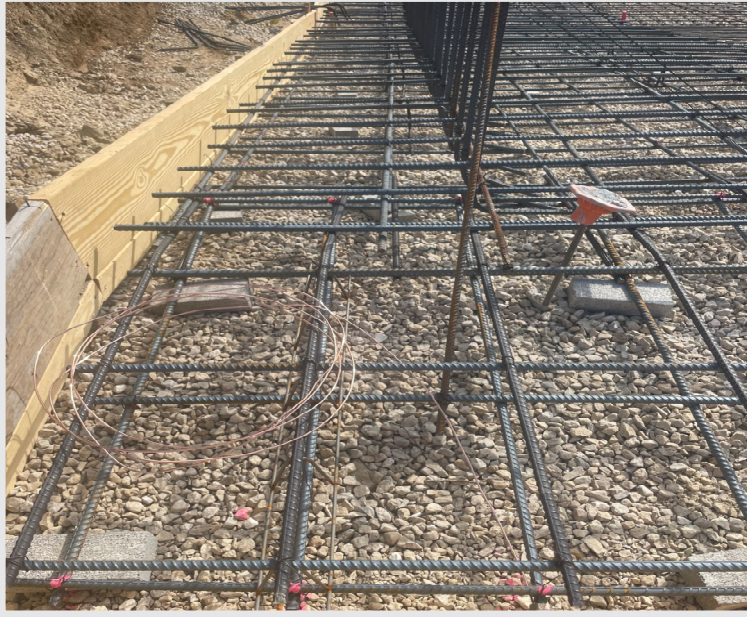
Above: A photo showing what the grounding, that was mentioned in the fun fact, looks like. Look closely for the wire and its connection to the rebar.

Grounding is used at pools to ensure that all potential electrical current is dissipated to the ground and away from the pool equipment and people. Grounding is completed by taking bonded pool components, like the rebar shown in some of these photos, and connecting them to the earth. Special safety measures are considered when building pools, and grounding is one of the unique ones that not everyone gets to see!

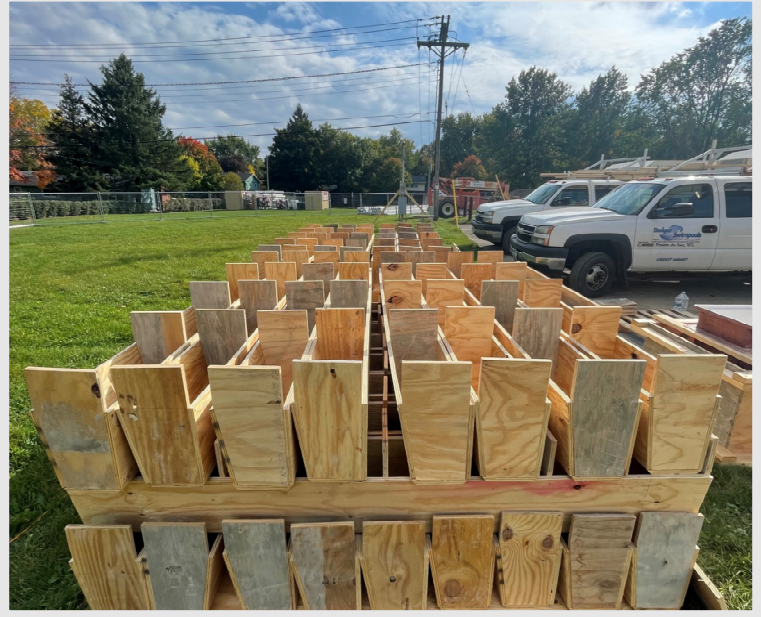
Above: Crews have already started prefabbing the forms for the pool gutters that exist at the top of the pool walls. They'll prefab these forms to stay ahead and efficient when it comes time for the pour.

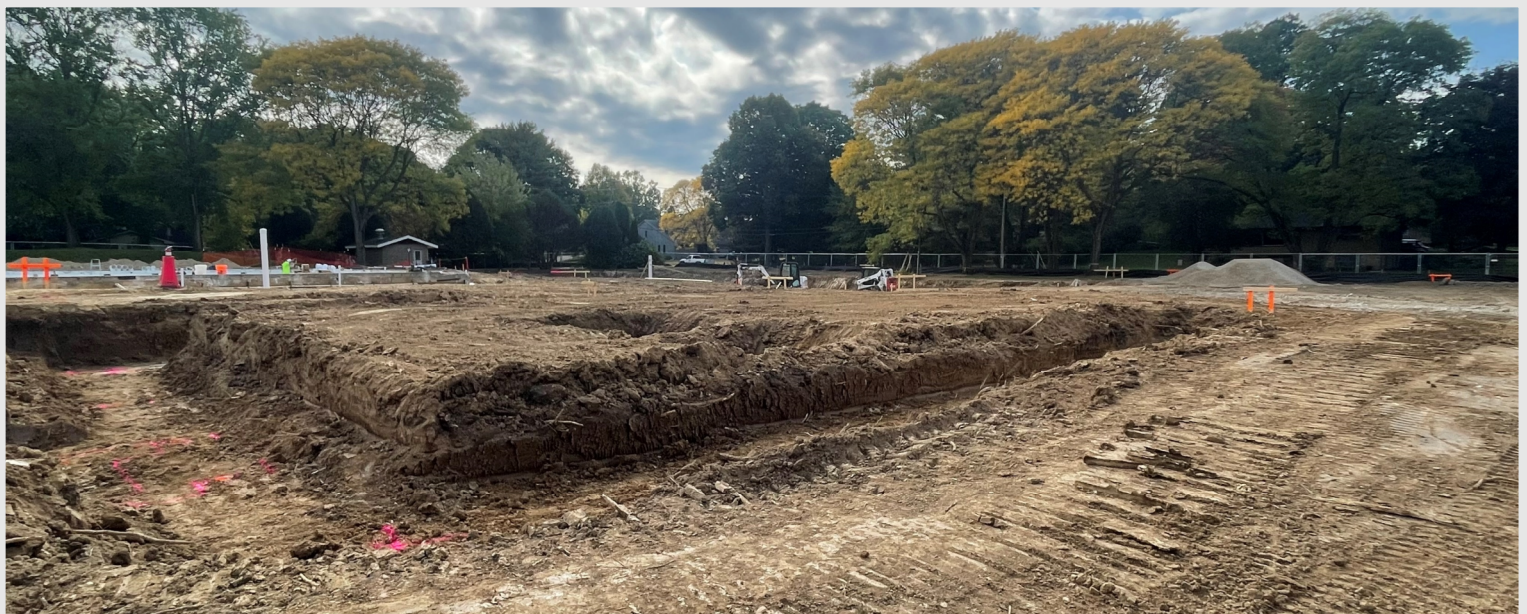
Above: A photo showing the start of the excavations for the new pool house. Footings and foundations will start next week!
