Ridgewood Pool EXECUTIVE SUMMARY

PROVIDED BY FINDORFF

5109 Barton Rd • Madison, WI 11.04.2022

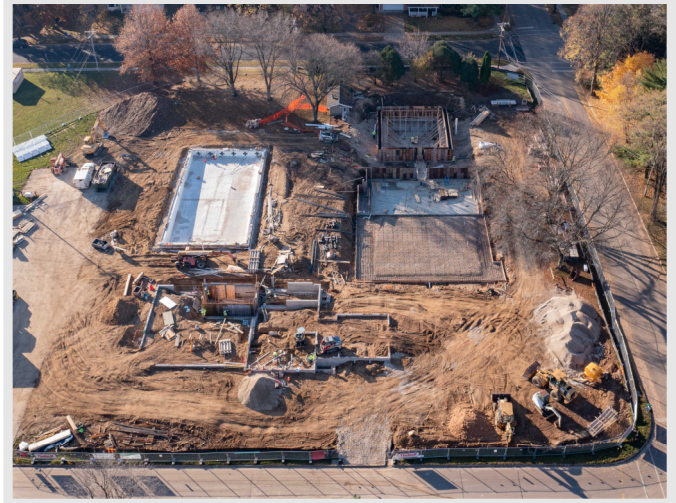
Above: Drone photo taken from Barton Rd. showing the layout of the new pool house at the bottom, existing lap pool in the top left corner, and the new dive well and competition/recreation pool in the top right corner.

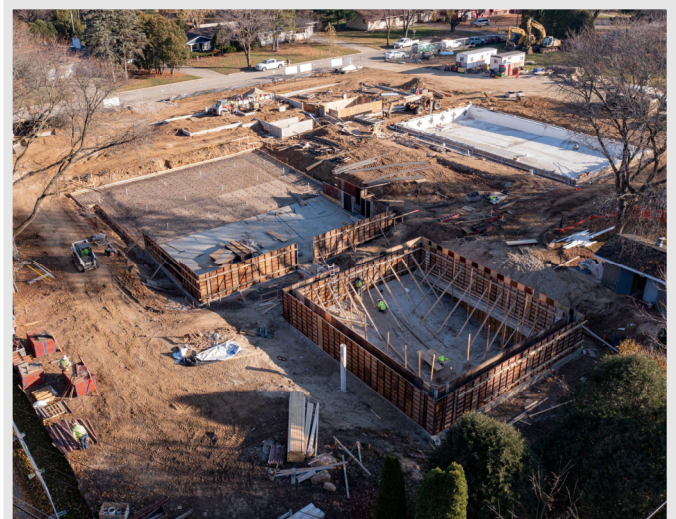
Below: A view from the southwest corner of the site showing a better look at the new dive well and competition/recreation pool.

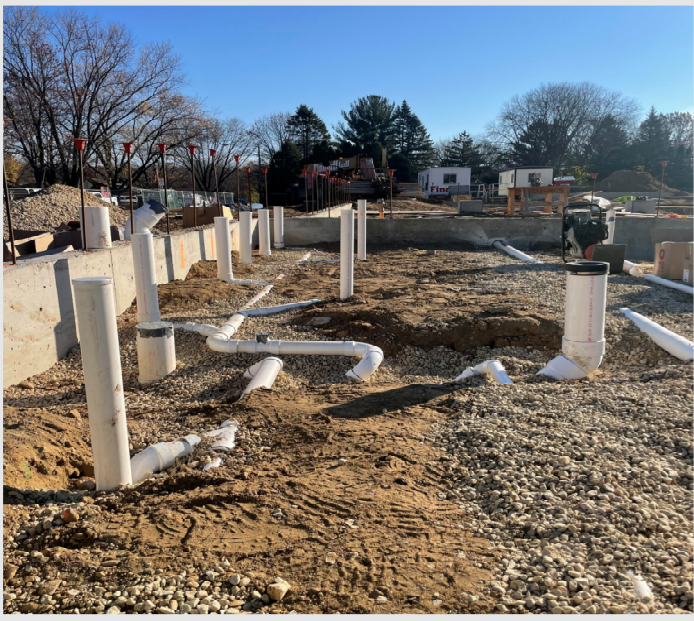
Above: Underground plumbing is underway at the new pool house. This means that the concrete floor slab is right around the corner!

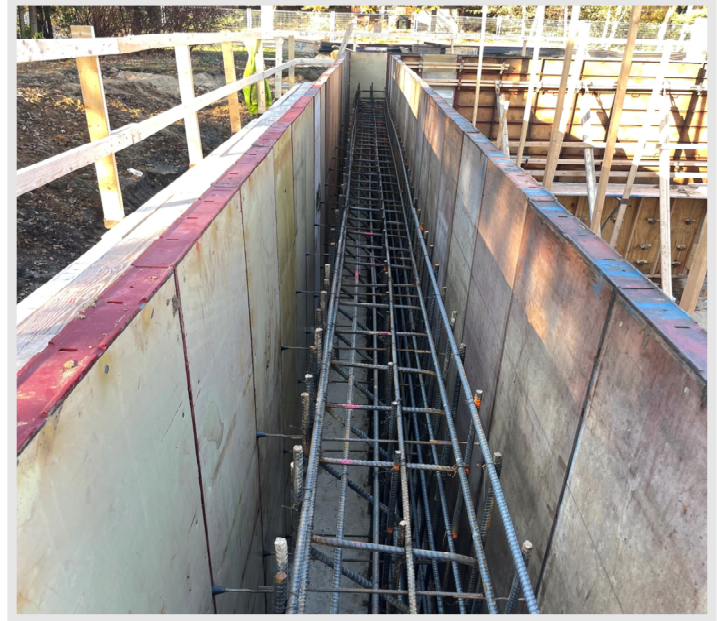
Above: Look at all of that reinforcing! This is a photo of the highwalls at the dive vessel. The tops of these walls will be over 24" thick to create space for the gutter that wraps the perimeter of the vessel.

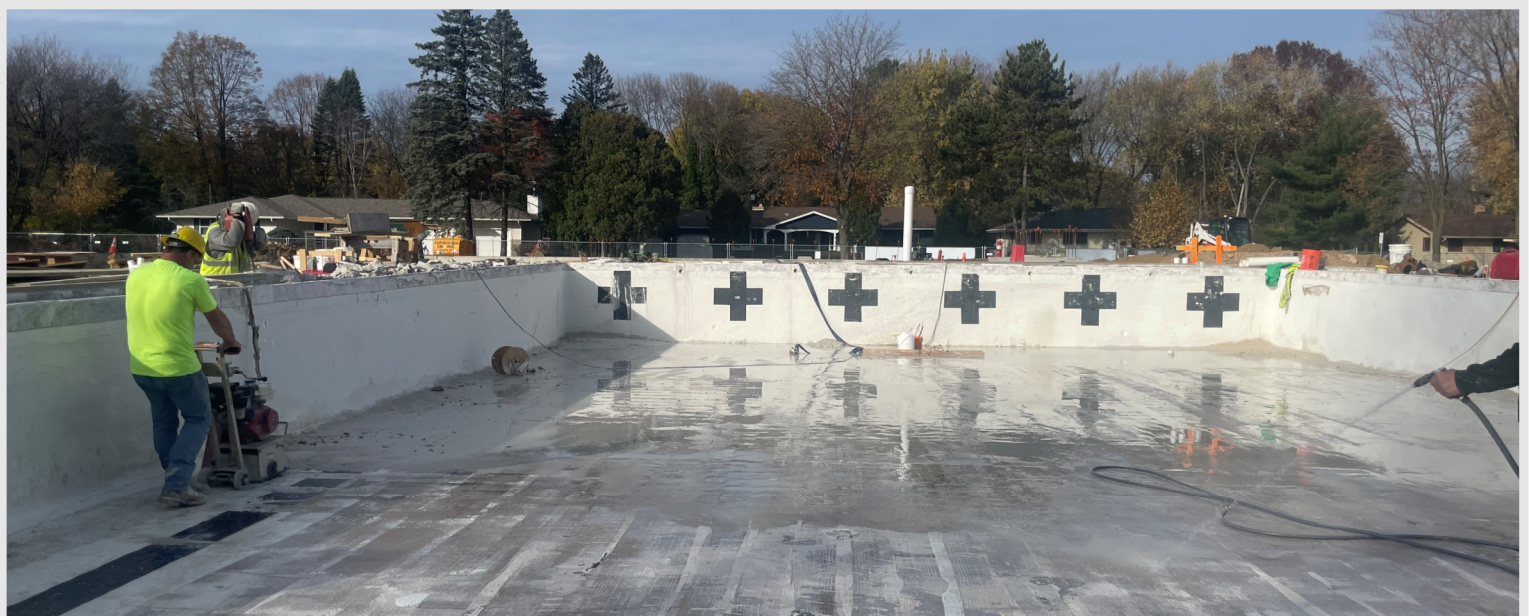
The existing pool is receiving a new plaster finish similar to that of the other pools. Prior to waterproofing and installing the final coat, a process called scarifying needs to take place. Scarifying is the process that uses a scarifying machine that has spinning metal blades that help to grind and chip away at the top layer of the concrete surface to remove any existing coatings while leveling the concrete in preparation for the new plaster finish to be applied.

Above: A photo showing the scarfing process occurring at the existing lap pool that was described in this week's fun fact.
